Case Study: Fuel Leakage in the Fuel Drain Area of the Tank Ejector on the Airbus A330-300 Engine

James Siregar*, Lalu Giat Juangsa Putra, Muhammad Andi Nova, Mohamad Alif Dzulfiqar, Nur Rafia Dija, Tsabita Salmahirah, Rizky Pratama Hudhajanto

Keywords: Fuel Leakage, Fuel Drain System, Airbus A330-300, Aircraft Maintenance

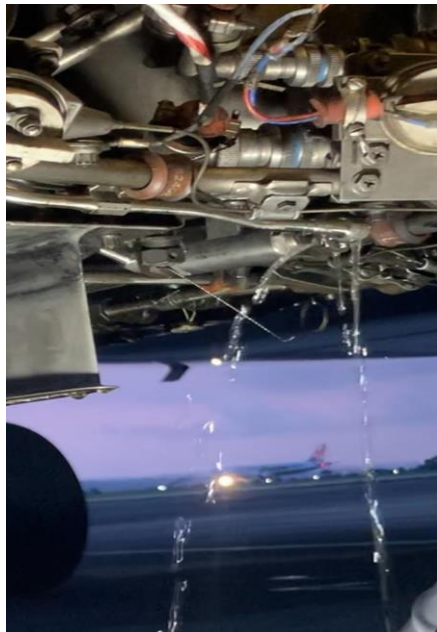
Figure 6. Fuel leak

The initial investigation involved a thorough visual inspection of the two main connection points on the fuel drain tank ejector. The observations revealed a stain-type leak with a wet area less than half an inch in diameter, specifically isolated to the left-hand input connector, whilst the right-hand connector was confirmed to be in normal condition with no signs of seepage. Figure 6 shows the fuel leak. Qualitatively, the degradation of the left-hand connector indicates a reduction in mechanical structural

whilst the connector is being removed. According to TSM 71-71-00-810-801-A, in the event of a leak, the procedure to follow is to remove and reinstall the fuel drain tank ejector. Figures 7 and 8 show a schematic of the fuel drain tank ejector for reference during the connector removal process.

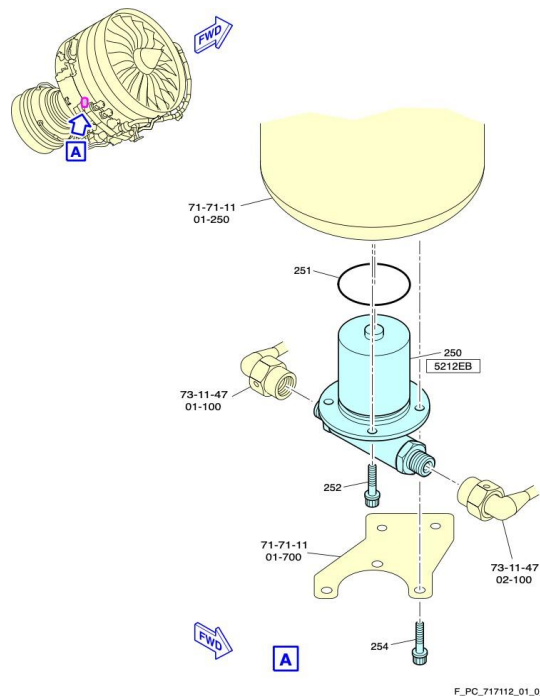
Figure 7. Fuel Drains Tank Ejector Schematic integrity, resulting in the seal ring no longer being able to withstand fluid pressure optimally. The subsequent troubleshooting process to remove and replace this component presents its own challenges in the field, particularly regarding the extremely limited working space beneath the fuel drain collector tank, which makes it difficult to manoeuvre tools such as a torque wrench to achieve precise torque. Furthermore, technicians must manage the remaining aviation fuel with the utmost care, using specialised collection

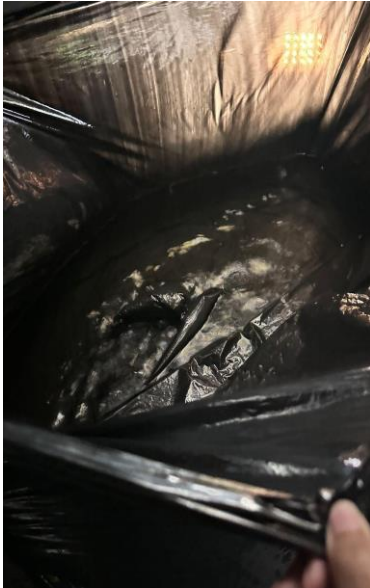
Figure 9. Documentation of the fuel that has been collected

Once the fuel has been drained, the retaining bolts are loosened and the used seal ring is removed and discarded. As a safety measure, all openings are covered with protective covers. Secondly, the installation stage (Task 71-71-42-400-804-A) begins by removing the protective cover. A new seal ring (P/N AS43013-131) is fitted to the ejector before the component is repositioned on its bracket. The bolts are tightened to a standard

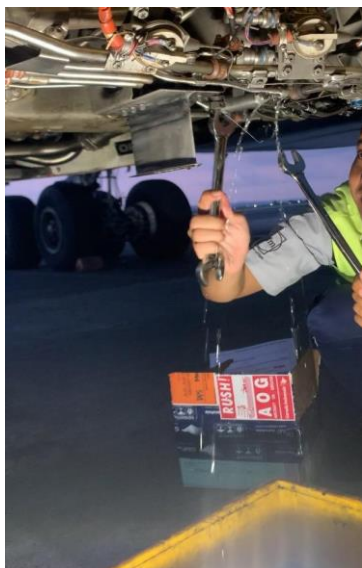
Figure 10. Connector Removal Documentation

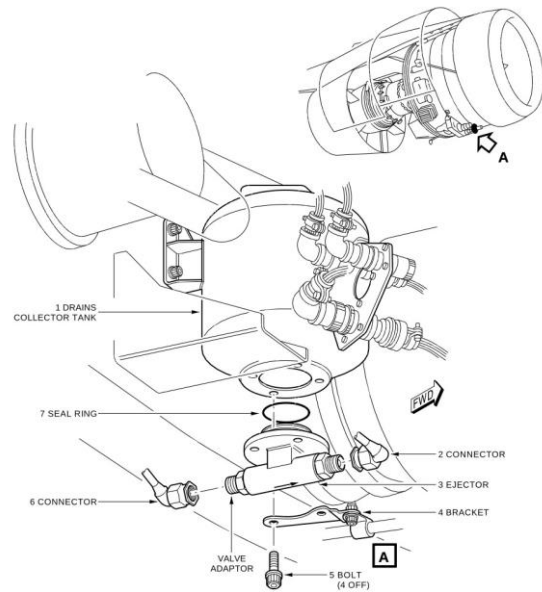
Figure 8. Fuel Drains Tank Ejector m.daN). Next, the connector is connected and tightened to a torque of between 193.5 and 236.5 lbf.in (2.19 and 2.67 m.daN). The procedure is completed by fitting a locking wire to the connector to ensure the connection is securely fastened and does not come loose.

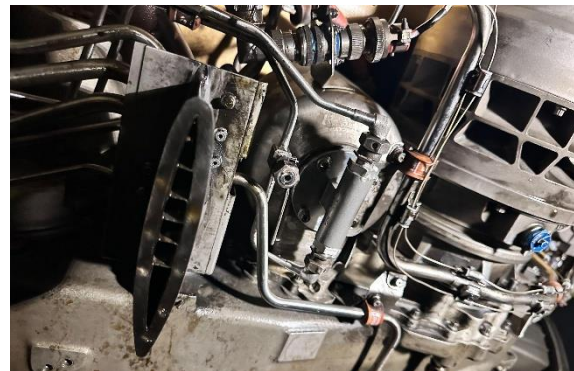
Figure 11. The Replaced Connector and the Fuel Tank Ejector After Reinstallation
