Landslide Intensity and Potential Based on Geomorphology and Their Relationship to the Stadia Level of The Karanggayam River, Kebumen Regency, Central Java Province, Indonesia

Keywords: Landslide, Geomorphology, Stadia Level River, Karanggayam River

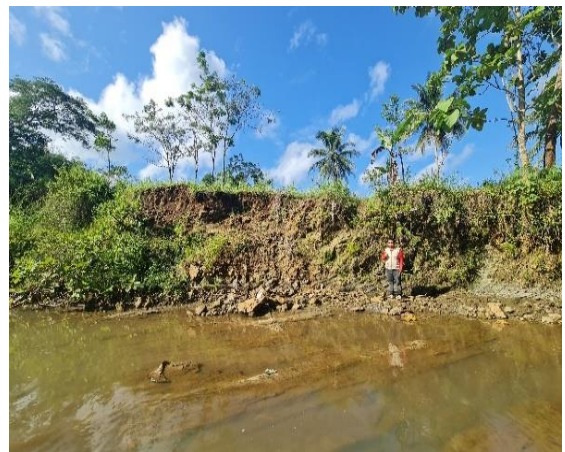
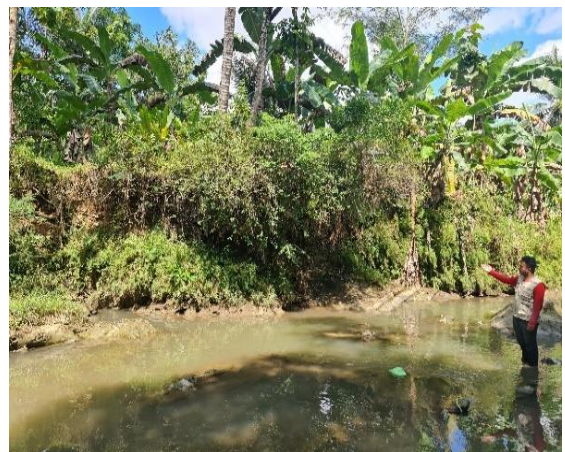
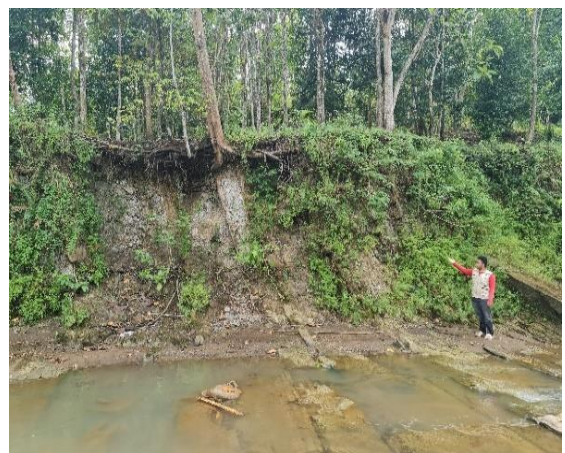
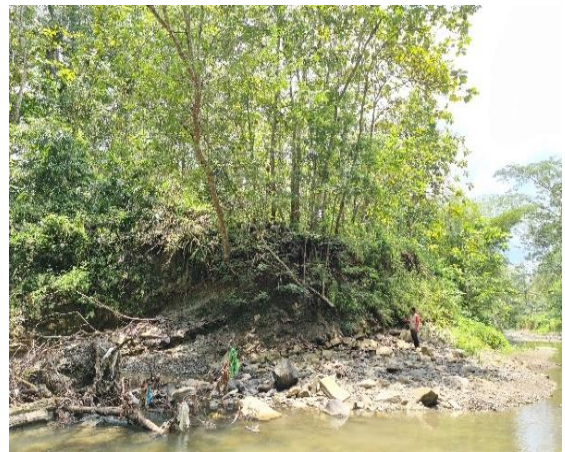
The results of field observations in the area where the river body is shaped show four landslide disaster occurrence points (Figure 2) and six potential landslides (Figure 3) that occur in the river flow. Landslides and potential landslides occur only locally along the river flow and are caused by scouring or lateral erosion by river flow at the outer bend of a river with large slopes and relatively weathered rocks. The role of geomorphology in landslide disasters has

Figure 2. Landslides occurred in areas along the Karanggayam River

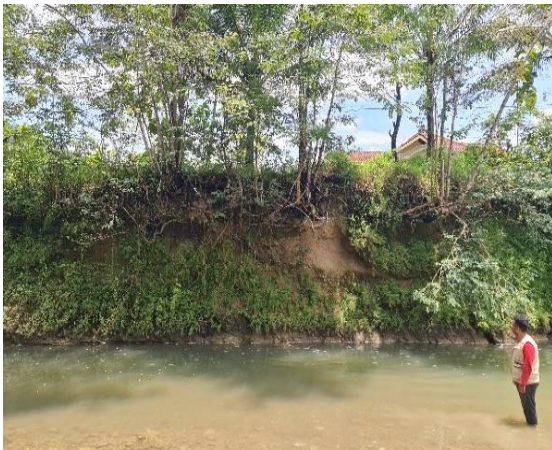
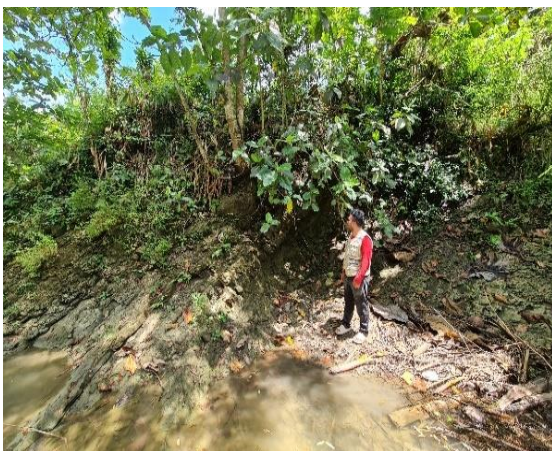
Figure 3. Potential for landslides in areas along the Karanggayam River
