## Sedimentation And Abrasion Identification in Cikidang Fishery Port and Surrounding Coastal Area

**Keywords:** Abrasion, Sedimentation, Cikidang Fishery Port

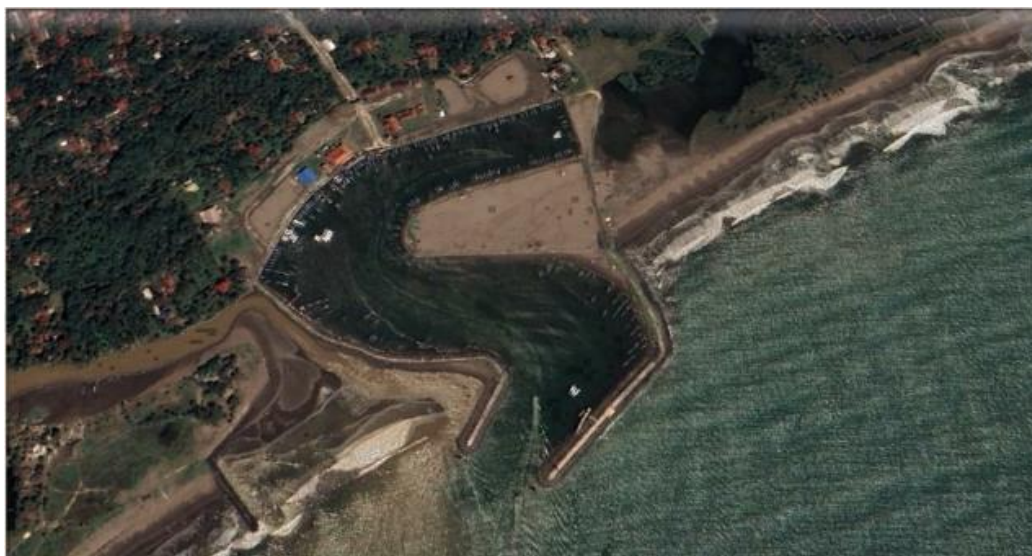
**Figure 1.** Cikidang Fisheries Port Waters and surrounding coastal areas.  
Source: <https://earth.google.com/>

The research site is on the east coast of Pangandaran. Figure 1 illustrates the coastal area that has undergone sedimentation and abrasion. The research was conducted for 3 days from February 19 to February 21, 2021.

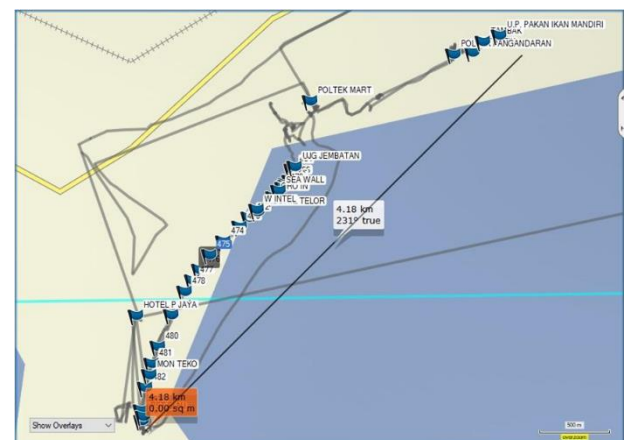
**Figure 2.** Coastline tracking results  
Source: GPS Tracking

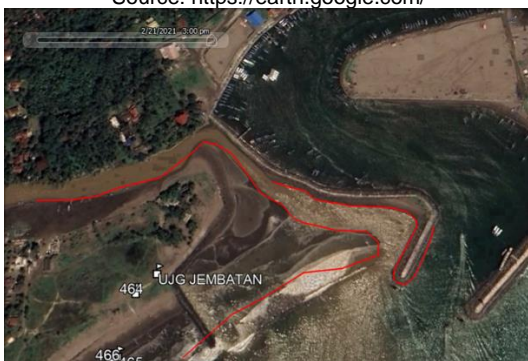
**Figure 6.** Coastal Shoreline of the Area Surrounding the Current Western Breakwater

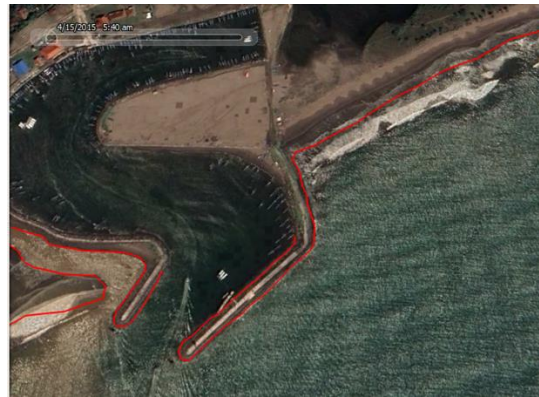
**Figure 7.** Coastal Coastline of the Eastern Breakwater Area of Cikidang Fishing Port

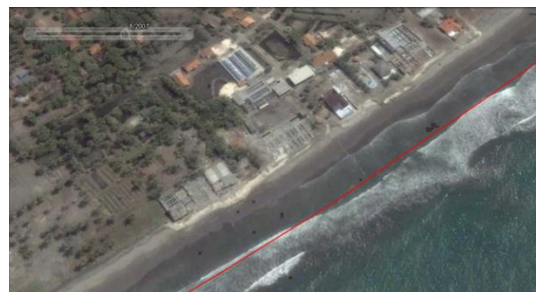
**Figure 8.** Abrasion on the West Coastline in 2007

Abrasion continues to occur on the west coast due to strong currents from the Antarctic Ocean, which have begun to decrease since the construction of the Groyne. In the period from 2006 to 2010, there was a retreat of the coastline towards the mainland along 37.44 meters.

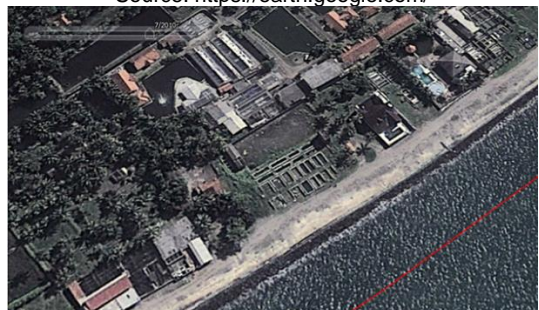
**Figure 9.** Abrasion on the West Coastline in 2010

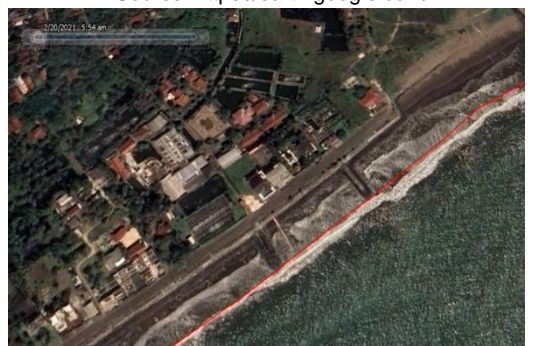
**Figure 10.** Abrasion on the West Coastline in 2021

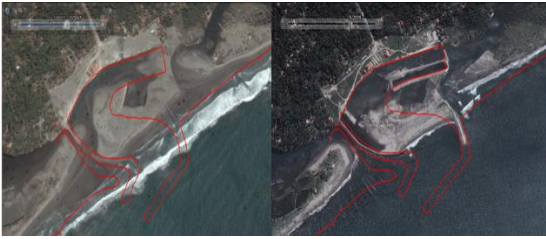
**Figure 11.** Satellite Image of PP Cikidang Before the Breakwater was built in 2007 (left) and Satellite Image of PP Cikidang After Abrasion Period 2007 – 2009 (right)

Initially, the period from 2007 to 2009 marked a critical phase in which the coastline experienced the most substantial abrasion, measuring approximately 6.4 meters. This erosion was primarily driven by powerful oceanic forces, including solid wave action and prevailing currents relentlessly attacking the shoreline. The implications of this erosion were significant, as it threatened local infrastructure, including homes, roads, and the vital Cikidang Fishery Port. The loss of land to the sea due to erosion can lead to detrimental effects on the coastal ecosystem, including habitat loss for various species and increased shoreline vulnerability to future erosion events.
