Case Study: Fuel Leakage in the Fuel Drain Area of the Tank Ejector on the Airbus A330-300 Engine

James Siregar*, Lalu Giat Juangsa Putra, Muhammad Andi Nova, Mohamad Alif Dzulfiqar, Nur Rafia Dija, Tsabita Salmahirah, Rizky Pratama Hudhajanto

Keywords: Fuel Leakage, Fuel Drain System, Airbus A330-300, Aircraft Maintenance

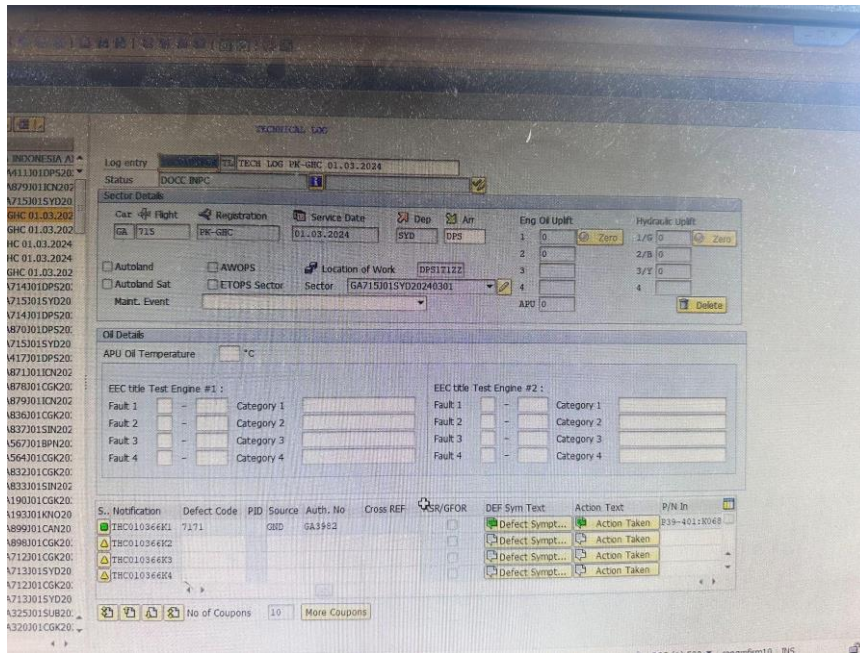
Figure 12. Swift Technical Log A330

The final step is to enter the Swift code as part of the aircraft data that has been processed, as shown in Figure 12. Damage to the fuel drain connectors on the ejector tank directly disrupts the optimal cycle of the engine drain system, whereby fuel that should be drawn from the collector tank to the LP fuel pump becomes blocked and instead accumulates. This accumulation of uncirculated fluid creates pressure anomalies and increases the risk of leaks escalating into active pooling, a condition consistent with previous literature which confirms that physical component degradation is a major contributor to fuel system failures that have fatal implications for operational safety. The corrective findings in this case also reinforce studies on preventive maintenance, wherein the
